# CITY OF REDMOND FACILITIES STRATEGIC MANAGEMENT PLAN

# RESOURCES

PRE-FINAL DRAFT

Prepared by:  
MAKERS architecture and urban design LLP

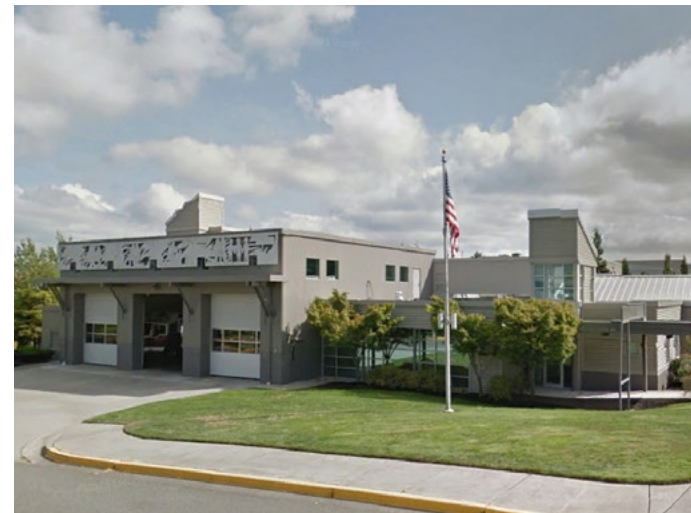
IMAGE 6. Fire Station 16

**SEISMIC CONNECTION BETWEEN ROOF AND TOWER**  
**CARPET FLOORING**  
**HVAC SYSTEM AT END OF LIFE AND HVAC NOISE**  
**HVAC CODE VIOLATIONS**  
**INADEQUATE ELECTRICAL SYSTEMS**

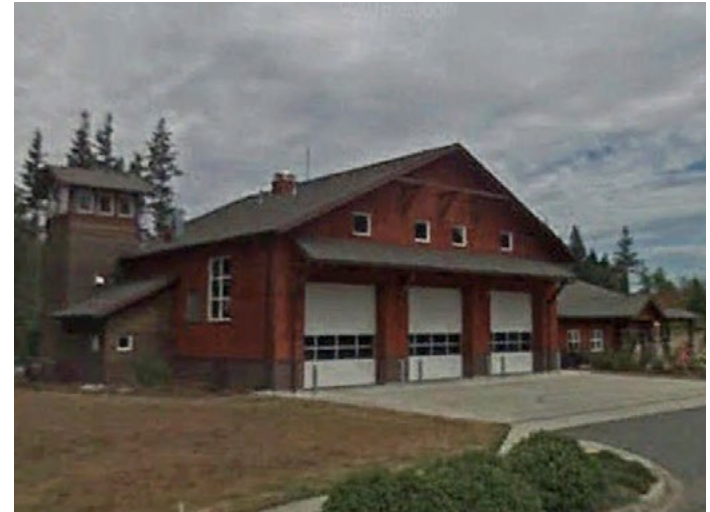
IMAGE 9. Fire Station 18

Major Deficiencies  
**MEZZANINE ACCESS**  
**INADEQUATE HOT WATER SUPPLY**  
**FOUNDATION AND K-BRACE SEISMIC**  
**VULNERABILITY**

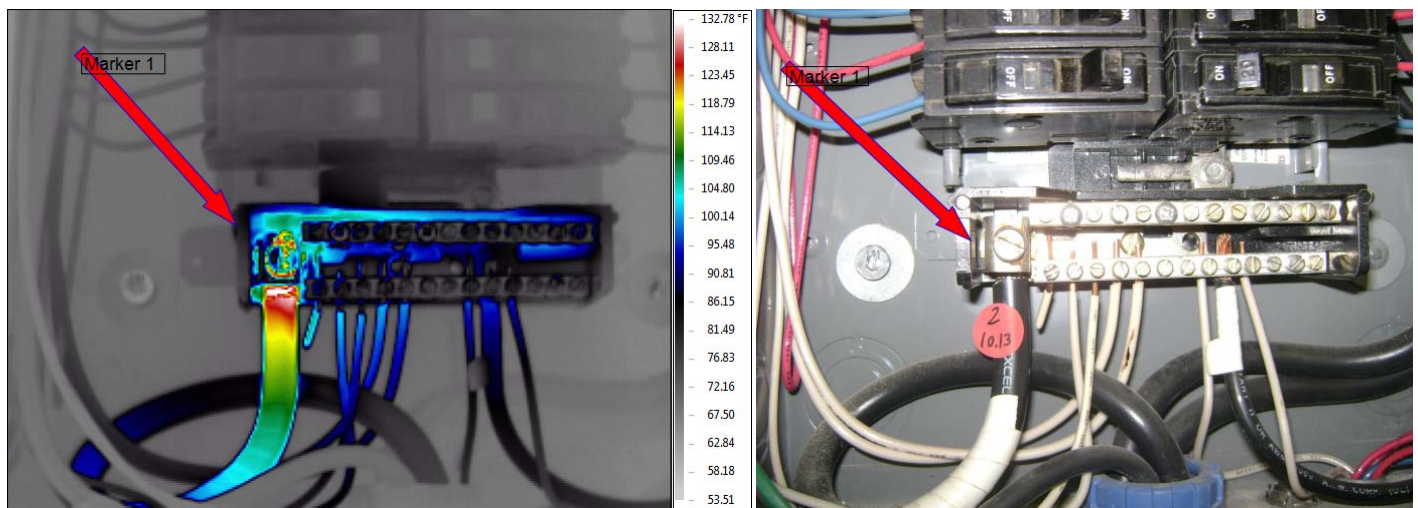
**Comment:** Stripped lug on main neutral wire on terminal strip

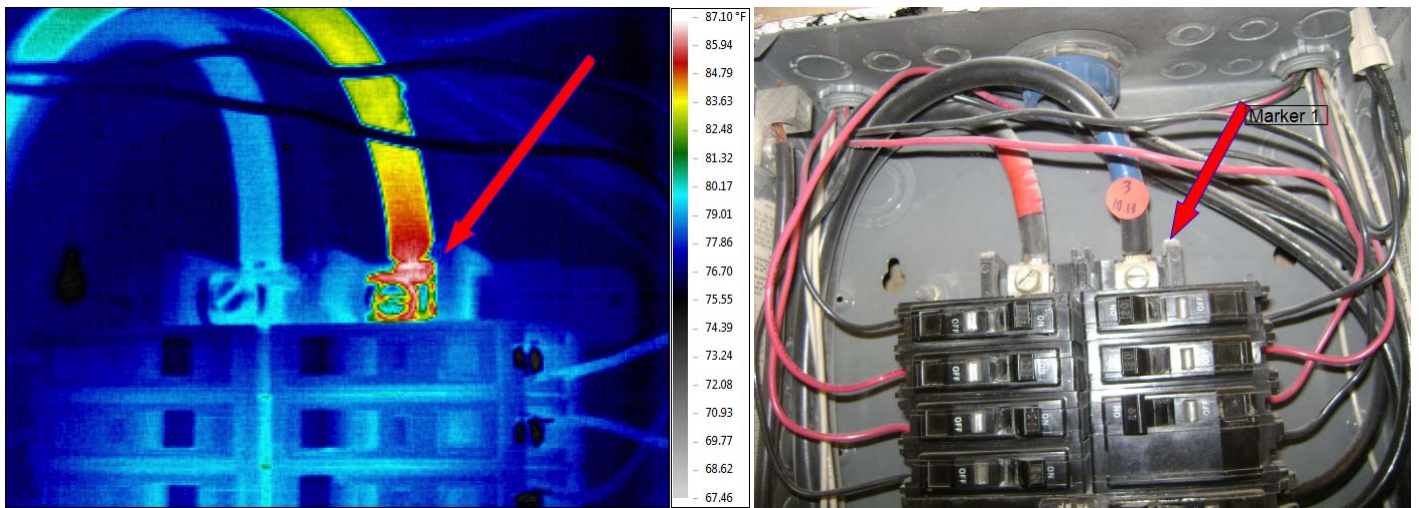
**Comment:** B phase line side wire lug connection on incoming lines

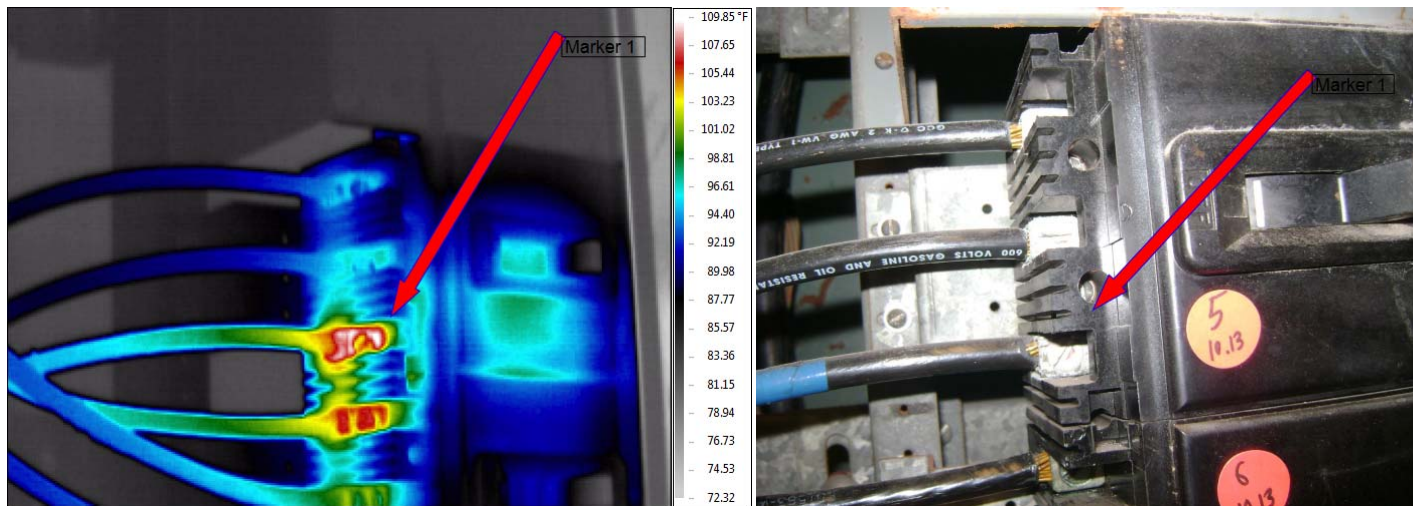
**Comment:** C phase load side wire lug connection on breaker "Panel BR"

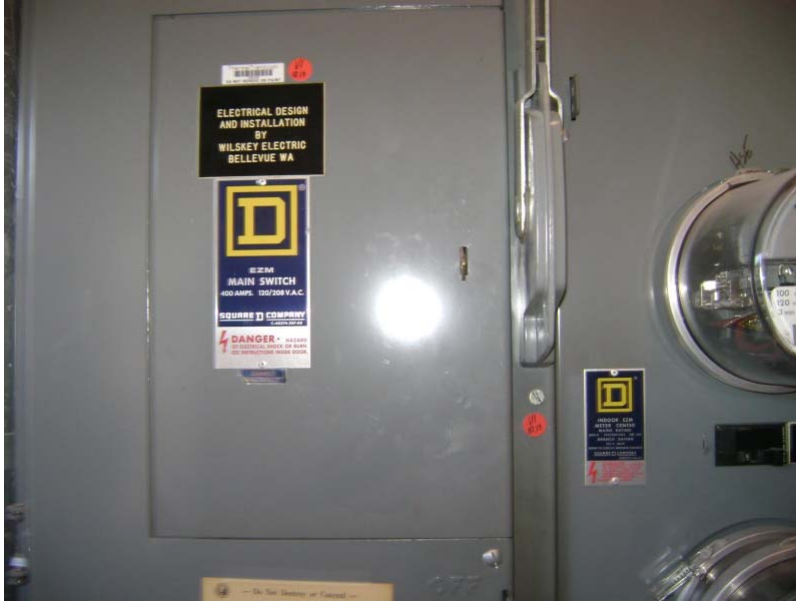
**Description:** Safety Bypass is broken

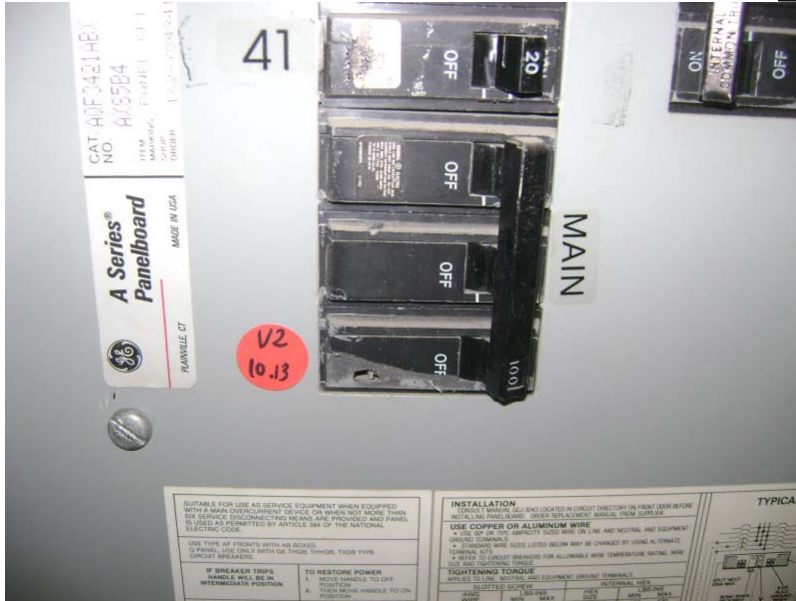
**Description:** Main Breaker is broken, exposed metal on C phase of 3-pole 100amp breaker
